# Access Compliance Report Public Rights-of-Way (Curb Ramps)

Main Street: MARTHA\_ANN\_DR Cross Street: BOSTONIAN\_DR Location: E

ADA ID: RPRK211220130724 Ramp Type: Type 4 - Parallel Initial Pass/Fail: Fail Overall Compliance: No Severity Score: 2

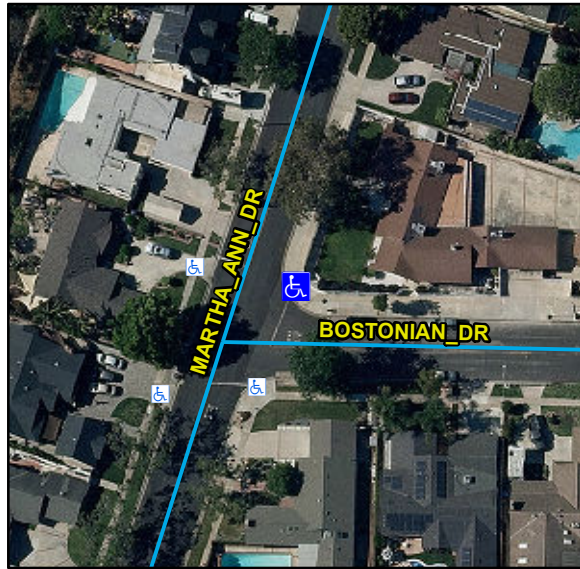
| Compliance | Description | Data | Compliance | Description | Data |
|---|---|---|---|---|---|
| No | Ramp Cross Slope LT (%) | 3.4 | Yes | Ramp Cross Slope RT (%) | 2 |

Remove & Replace Curb Ramp With Two New Directional Ramps or Equivalent.

R204.3, R304.5.3, STD 1115
