# Access Compliance Report Public Rights-of-Way (Curb Ramps)

Main Street: BOSTONIAN\_DR Cross Street: MARTHA\_ANN\_DR Location: S

ADA ID: RPRK211220131153 Ramp Type: Type 4 - Parallel Initial Pass/Fail: Fail Overall Compliance: No Severity Score: 15

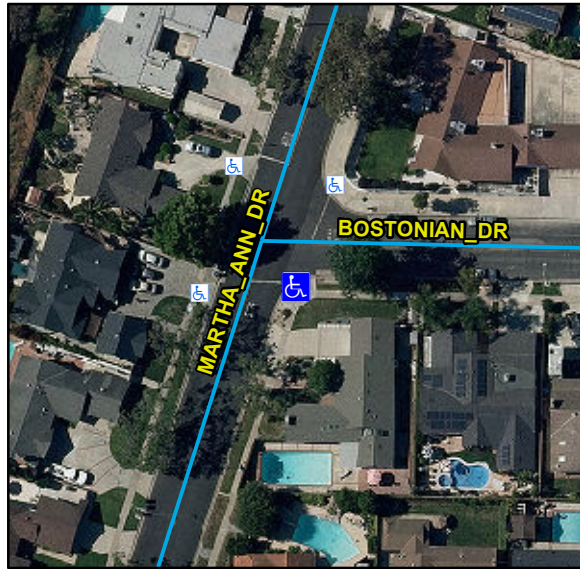
| Compliance | Description | Data | Compliance | Description | Data |
|---|---|---|---|---|---|
| Yes | Ramp Run Slope LT (%) | 3.7 | Yes | Ramp Run Slope RT (%) | 6.5 |
| No | Ramp Cross Slope LT (%) | 6.7 | No | Ramp Cross Slope RT (%) | 3.8 |

**Remove & Replace Curb Ramp With Two New Directional Ramps or Equivalent.**

**R204.3, R304.5.3, STD 1115**

Total Cost: \$ 4000
