# Access Compliance Report Public Rights-of-Way (Curb Ramps)

Main Street: FOSTER\_RD Cross Street: BOSTONIAN\_DR Location: SW

ADA ID: RPRK211220131814 Ramp Type: Type 1 - Perpendicular Diagonal Initial Pass/Fail: Pass Overall Compliance: No Severity Score: 0

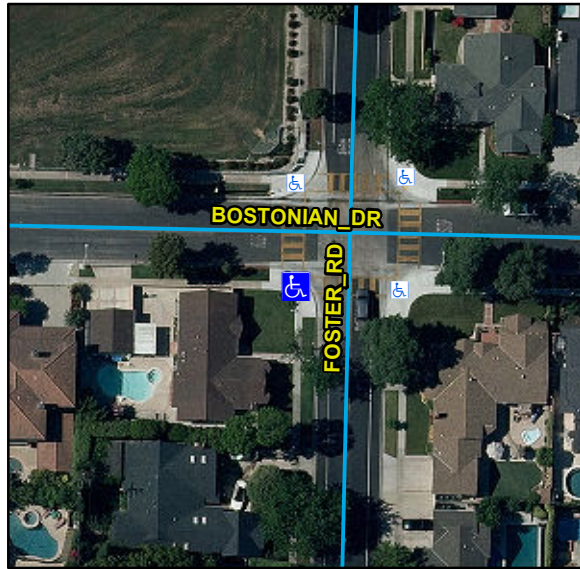
| Compliance | Description | Data | Compliance | Description | Data |
|---|---|---|---|---|---|
| N/A | Landing Movement Obstructed? | Yes | Yes | DWS Contrast | Yes |
| | Landing Movement Type | Curb | Yes | DWS Length (in) | 36 |

Possible Solutions:

Remove & Replace Landing.

R304.2.1, STD 1115
