# Access Compliance Report Public Rights-of-Way (Curb Ramps)

Main Street: BOSTONIAN\_DR Cross Street: FOSTER\_RD Location: SE

ADA ID: RPRK211220132246 Ramp Type: Type 1 - Perpendicular Diagonal Initial Pass/Fail: Fail Overall Compliance: No Severity Score: 15

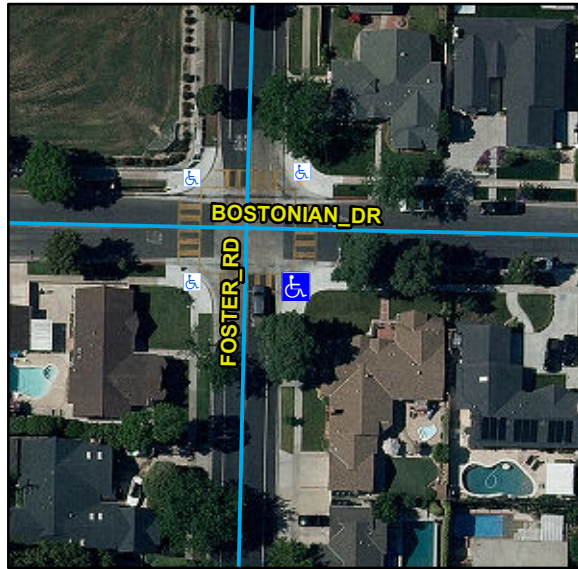
| Compliance | Description | Data | Compliance | Description | Data |
|---|---|---|---|---|---|
| No | Ramp Run Slope (%) | 8.7 | N/A | Flare Slope LT (%) | N/A |

Remove & Replace Curb Ramp With Two New Directional Ramps or Equivalent.

R304.2.2, STD 1115
