# Access Compliance Report Public Rights-of-Way (Curb Ramps)

Main Street: FOSTER\_RD Cross Street: BOSTONIAN\_DR Location: NE

ADA ID: RPRK211220132533 Ramp Type: Type 1 - Perpendicular Diagonal Initial Pass/Fail: Pass Overall Compliance: No Severity Score: 0

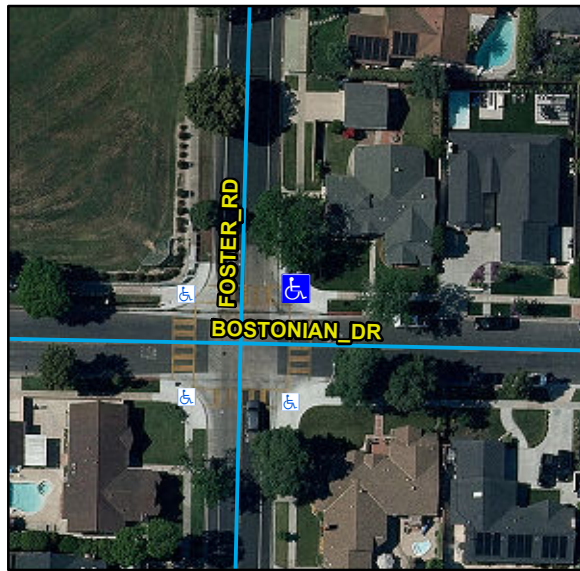
## Field Measurements/Component Compliance

| Compliance | Description | Data | Compliance | Description | Data |
|---|---|---|---|---|---|
| No | Landing Run Slope (%) | 2.1 | N/A | Flare Traversable RT | No |

Remove & Replace Landing.

R304.2.2-Perp, R304.3.2-Para, STD 1115
