# Access Compliance Report Public Rights-of-Way (Curb Ramps)

Main Street: BOSTONIAN\_DR Cross Street: FOSTER\_RD Location: NW

ADA ID: RPRK211220132824 Ramp Type: Type 1 - Perpendicular Diagonal Initial Pass/Fail: Pass Overall Compliance: No Severity Score: 0

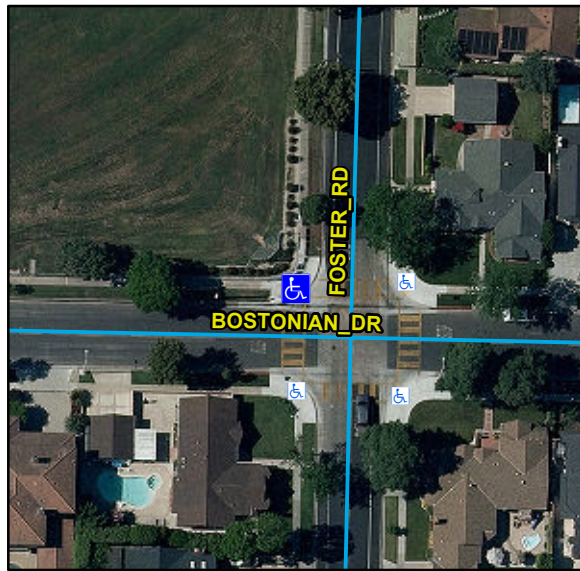
**Remove & Replace Landing. Gutter Ponding Observed.**

| Compliance | Description | Data | Compliance | Description | Data |
|---|---|---|---|---|---|
| No | Gutter Ponding | Yes | Yes | Curb Slope | 1.5 |

Possible Solutions:

**R304.2.1, R302.7, STD 1115**
