# Access Compliance Report Public Rights-of-Way (Curb Ramps)

Main Street: KENSINGTON\_RD Cross Street: MAIN\_WAY\_DR Location: SW

ADA ID: RPRK211220134030 Ramp Type: Type 1 - Perpendicular Diagonal Initial Pass/Fail: Pass Overall Compliance: No Severity Score: 10

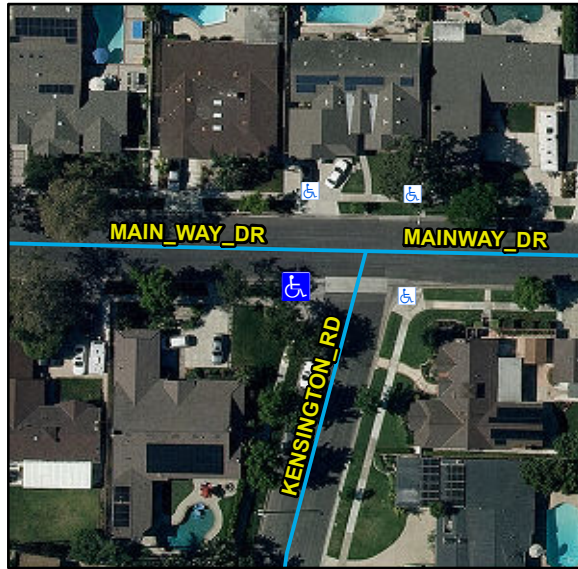
| Compliance | Description | Data | Compliance | Description | Data |
|---|---|---|---|---|---|
| Yes | Landing Cross Slope (%) | 0.5 | No | DWS Provided | No |

Remove & Replace Curb Ramp With Two New Directional Ramps or Equivalent.

R204.3, R305, STD 1115
