# Access Compliance Report Public Rights-of-Way (Curb Ramps)

Main Street: TUCKER\_LN Cross Street: KENSINGTON\_RD Location: SE

ADA ID: RPRK211220134521 Ramp Type: Type 1 - Perpendicular Diagonal Initial Pass/Fail: Pass Overall Compliance: No Severity Score: 10

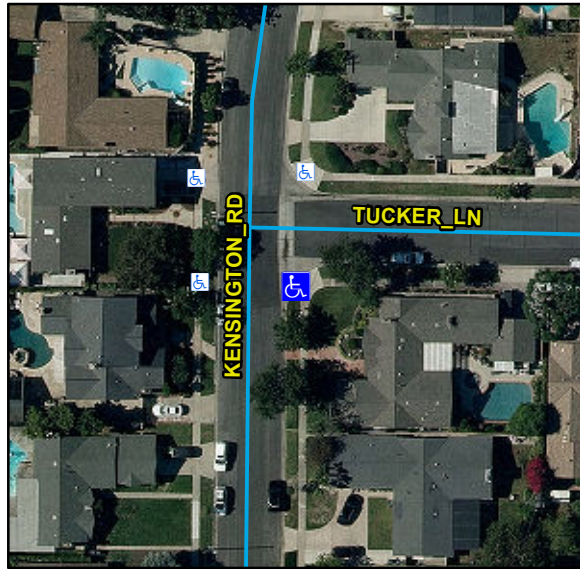
| Compliance | Description | Data | Compliance | Description | Data |
|---|---|---|---|---|---|
| No | Landing Run Slope (%) | 2.2 | N/A | Flare Traversable RT | No |
| Yes | Landing Cross Slope (%) | 0.9 | No | DWS Provided | No |

Remove & Replace Curb Ramp With Two New Directional Ramps or Equivalent.

R204.3, R304.2.2-Perp, R304.3.2-Para, R305, STD 1115
