# Access Compliance Report Public Rights-of-Way (Curb Ramps)

Main Street: KENSINGTON\_RD Cross Street: TUCKER\_LN Location: NE

ADA ID: RPRK211220134817 Ramp Type: Type 1 - Perpendicular Diagonal Initial Pass/Fail: Pass Overall Compliance: No Severity Score: 12

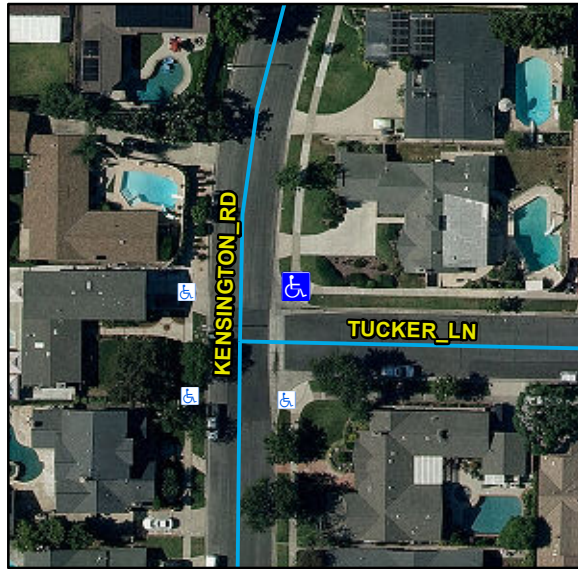
| Compliance | Description | Data | Compliance | Description | Data |
|---|---|---|---|---|---|
| Yes | Landing Cross Slope (%) | 1.3 | No | DWS Provided | No |

**Remove & Replace Curb Ramp With Two New Directional Ramps or Equivalent.**

**R204.3, R305, STD 1115**
