# Access Compliance Report Public Rights-of-Way (Curb Ramps)

Main Street: MAINWAY\_DR Cross Street: KENSINGTON\_RD Location: S

ADA ID: RPRK211220135117 Ramp Type: Type 1 - Perpendicular Diagonal Initial Pass/Fail: Pass Overall Compliance: No Severity Score: 12

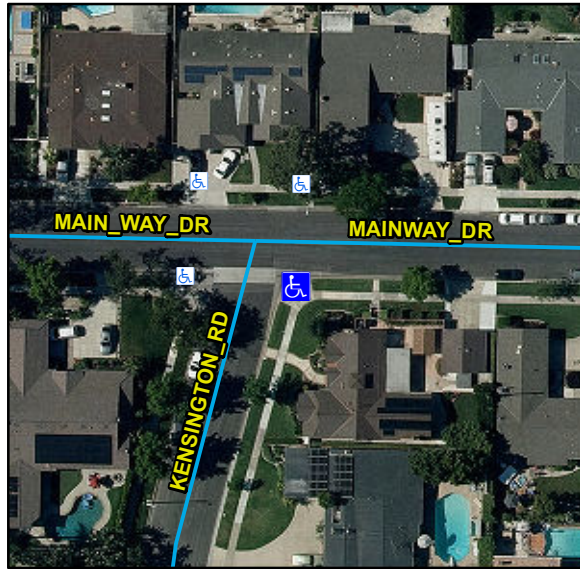
| Compliance | Description | Data | Compliance | Description | Data |
|---|---|---|---|---|---|
| No | Landing Run Slope (%) | 2.9 | N/A | Flare Traversable RT | No |
| Yes | Landing Cross Slope (%) | 0.5 | No | DWS Provided | No |

Remove & Replace Curb Ramp With Two New Directional Ramps or Equivalent.
