# Access Compliance Report Public Rights-of-Way (Curb Ramps)

Main Street: MARTHA\_ANN\_DR Cross Street: MAIN\_WAY\_DR Location: NE

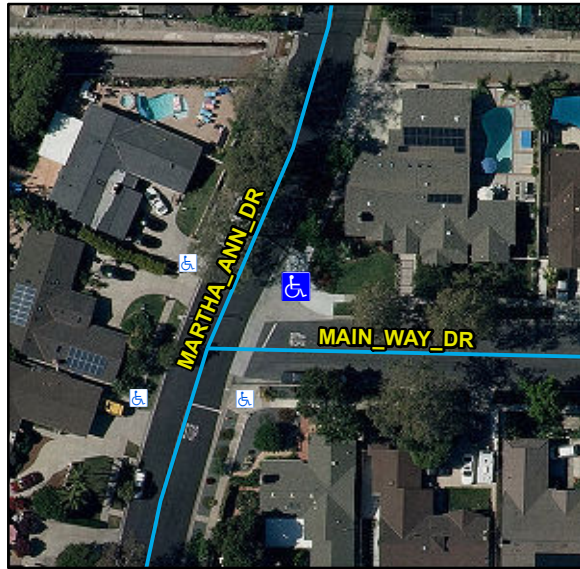
| Compliance | Description | Data | Compliance | Description | Data |
|---|---|---|---|---|---|
| No | Gutter Ponding | Yes | No | Curb Slope | 6.3 |
| Yes | Overall Surface Condition: Acceptable | | Yes | Perp Joint Present | Yes |

Remove & Replace Curb Slope.

R304.2.2, R302.7, STD 1115
