# Access Compliance Report Public Rights-of-Way (Curb Ramps)

**Main Street:** KEMPTON\_DR      **Cross Street:** MARTHA\_ANN\_DR      **Location:** S

**ADA ID:** RPRK211220140014      **Ramp Type:** Type 1 - Perpendicular Diagonal Initial Pass/Fail: Fail      **Overall Compliance:** No      **Severity Score:** 15

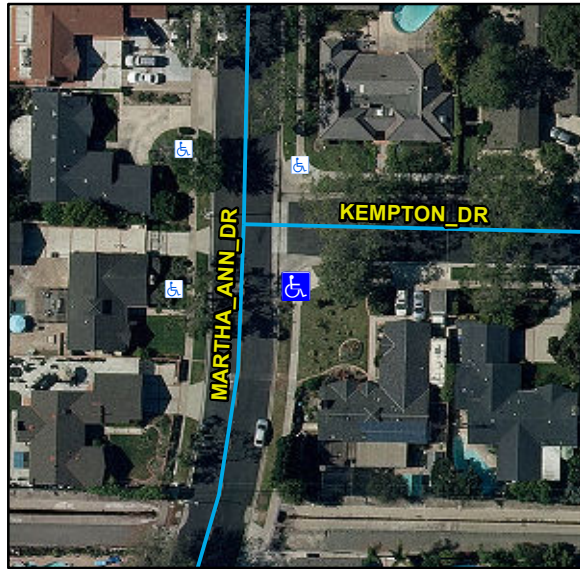
Compliance	Description	Data	Compliance	Description	Data
N/A	Ramp Length (in)	81	N/A	Flare Type LT	
Yes	Ramp Width (in)	48			N/A
No	Ramp Run Slope (%)	9.5	N/A	Flare Slope LT (%)	N/A
Yes	Ramp Cross Slope (%)	0.4	N/A	Flare Traversable LT	N/A
N/A	Landing Present	N/A	N/A	Flare Type RT	
N/A	Landing Length (in)	N/A			N/A
N/A	Landing Width (in)	N/A	N/A	Flare Slope RT (%)	N/A
N/A	Landing Run Slope (%)	N/A	N/A	Flare Traversable RT	N/A
N/A	Landing Cross Slope (%)	N/A	N/A	DWS Provided	N/A
N/A	Landing Movement Obstructed?	N/A	N/A	DWS Contrast	N/A
	Landing Movement Type	N/A	N/A	DWS Length (in)	N/A
N/A	Landing Shared	N/A	N/A	DWS Full Width	N/A
N/A	Clear Space	Yes	N/A	DWS Offset Left (in)	N/A
N/A	Clear Space To Crosswalk (in)	N/A	N/A	DWS Offset Right (in)	N/A
N/A	Marked Crosswalk 1	No	N/A	Marked Crosswalk 2	No
	Crossing 1 Direction	N		Crossing 2 Direction	W
	Marked Crosswalk 1 Width (in)	N/A		Marked Crosswalk 2 Width (in)	N/A

N/A	Ramp Inside Crosswalk 1	N/A	Yes	Ramp Inside Crosswalk 2	N/A
	Crossing 1 Slope (%)	2.7		Crossing 2 Slope (%)	6
	Crossing 1 Cross Slope (%)	1.4		Crossing 2 Cross Slope (%)	0.3
N/A	Gutter Ponding	N/A	N/A	Curb Slope	1.3
Yes	Gutter Lip Height (in)	0		Road Run Slope (%)	1.6
N/A	Gutter Run Slope (%)	N/A		Road Cross Slope (%)	0.6
N/A	Gutter Cross Slope (%)	N/A			
Yes	Overall Surface Condition: <b>Acceptable</b>		No	Perp Joint Present	No
	Cross Gutter Present?	Yes		Spandrel Present?	Yes
	Replace Cross Gutter?	No		Replace Spandrel?	No

**Possible Solutions:**  
Remove & Replace Curb Ramp With Two New Directional Ramps or Equivalent.
