# Access Compliance Report Public Rights-of-Way (Curb Ramps)

Main Street: GERTRUDE\_DR Cross Street: KENSINGTON\_RD Location: NW

ADA ID: RPRK211220141233 Ramp Type: Type 1 - Perpendicular Diagonal Initial Pass/Fail: Pass Overall Compliance: No Severity Score: 10

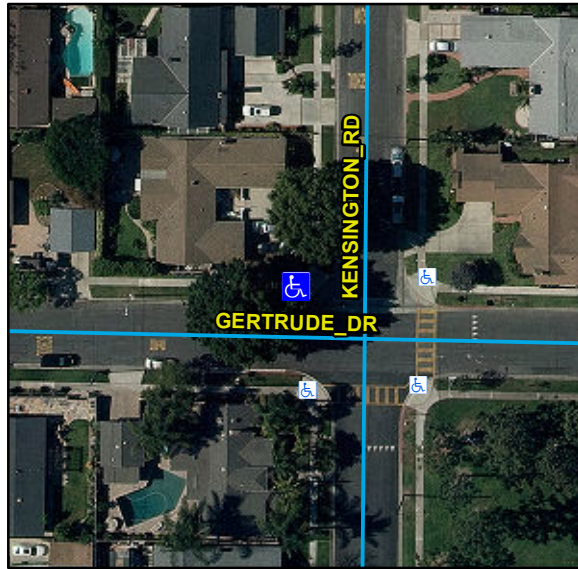
| Compliance | Description | Data | Compliance | Description | Data |
|---|---|---|---|---|---|
| No | Landing Run Slope (%) | 3.7 | N/A | Flare Traversable RT | No |
| Yes | Landing Cross Slope (%) | 0.7 | No | DWS Provided | No |
| No | Gutter Ponding | Yes | Yes | Curb Slope | 1.9 |

Remove & Replace Curb Ramp With Two New Directional Ramps or Equivalent. Gutter Ponding Observed.
