# Access Compliance Report Public Rights-of-Way (Curb Ramps)

| Main Street: KENSINGTON_RD | | Cross Street: GERTRUDE_DR | | Location: | NE |
| ADA ID: RPRK211220141635 | Ramp Type: Type 1 - Perpendicular Diagonal Initial Pass/Fail: Pass | | Overall Compliance: No | Severity Score: | 10 |

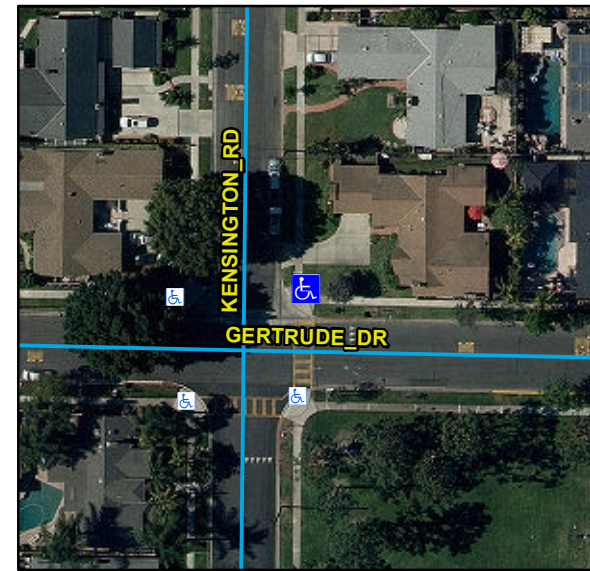
**R204.3, R304.2.2-Perp, R304.3.2-Para, R305, STD 1115**

| Compliance | Description | Data | Compliance | Description | Data |
|---|---|---|---|---|---|
| No | Landing Run Slope (%) | 2.6 | N/A | Flare Traversable RT | No |
| Yes | Landing Cross Slope (%) | 1.2 | No | DWS Provided | No |

Possible Solutions:

**Remove & Replace Curb Ramp With Two New Directional Ramps or Equivalent.**
