# Access Compliance Report Public Rights-of-Way (Curb Ramps)

Main Street: GERTRUDE\_DR Cross Street: KENSINGTON\_RD Location: SE

ADA ID: RPRK211220142105 Ramp Type: Type 1 - Perpendicular Diagonal Initial Pass/Fail: Fail Overall Compliance: No Severity Score: 15

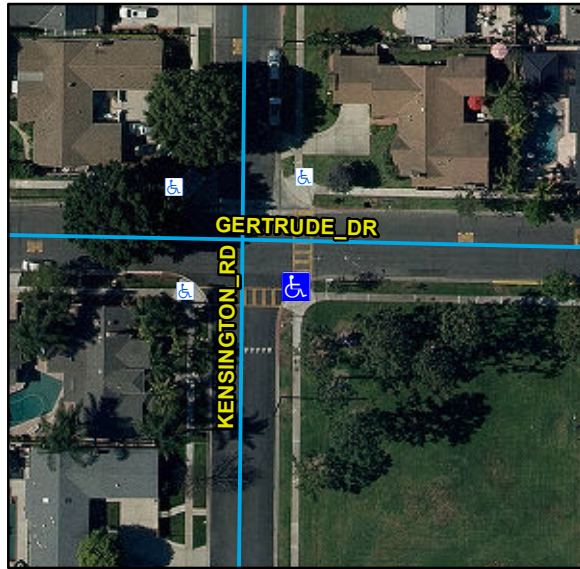
| Compliance | Description | Data | Compliance | Description | Data |
|---|---|---|---|---|---|
| No | Ramp Run Slope (%) | 8.7 | N/A | Flare Slope LT (%) | N/A |
| N/A | Gutter Ponding | N/A | No | Curb Slope | 9.4 |

**Remove & Replace Curb Ramp With Two New Directional Ramps or Equivalent.**

**R304.2.2, R204.3, STD 1115**
