# Access Compliance Report Public Rights-of-Way (Curb Ramps)

Main Street: KENSINGTON\_RD Cross Street: GERTRUDE\_DR Location: SW

ADA ID: RPRK211220142316 Ramp Type: Type 1 - Perpendicular Diagonal Initial Pass/Fail: Fail Overall Compliance: No Severity Score: 15

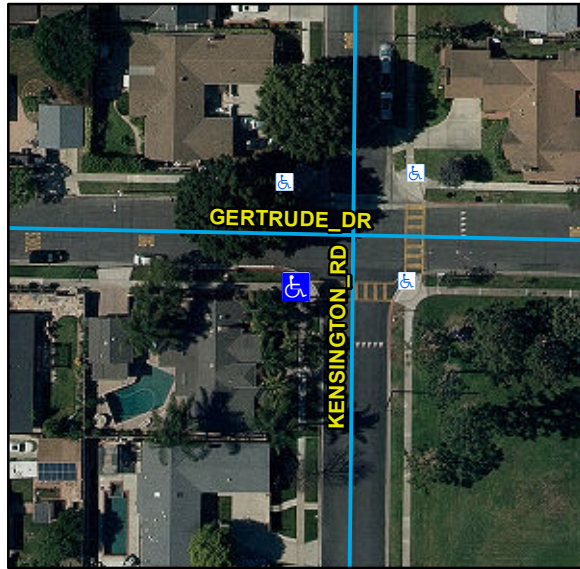
| Compliance | Description | Data | Compliance | Description | Data |
|---|---|---|---|---|---|
| No | Ramp Run Slope (%) | 8.5 | N/A | Flare Slope LT (%) | N/A |

**Remove & Replace Curb Ramp With Two New Directional Ramps or Equivalent.**

**R304.2.2, R204.3, STD 1115**
