# Access Compliance Report Public Rights-of-Way (Curb Ramps)

Main Street: GERTRUDE\_DR Cross Street: MARTHA\_ANN\_DR Location: SE

ADA ID: RPRK211220142516 Ramp Type: Type 1 - Perpendicular Diagonal Initial Pass/Fail: Pass Overall Compliance: No Severity Score: 0

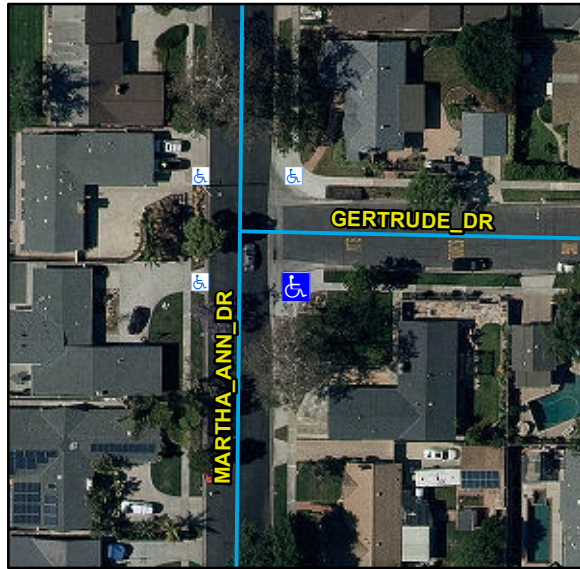
| Compliance | Description | Data | Compliance | Description | Data |
|---|---|---|---|---|---|
| No | Landing Run Slope (%) | 2.2 | N/A | Flare Traversable RT | No |
| Yes | Gutter Ponding | No | No | Curb Slope | 5.5 |

Remove & Replace Curb Ramp With Two New Directional Ramps or Equivalent.
