# Access Compliance Report Public Rights-of-Way (Curb Ramps)

Main Street: BRADBURY\_RD Cross Street: SEAL\_BEACH\_BLV Location: SE

ADA ID: RPRK211221110906 Ramp Type: Type 4 - Parallel Initial Pass/Fail: Fail Overall Compliance: No Severity Score: 15

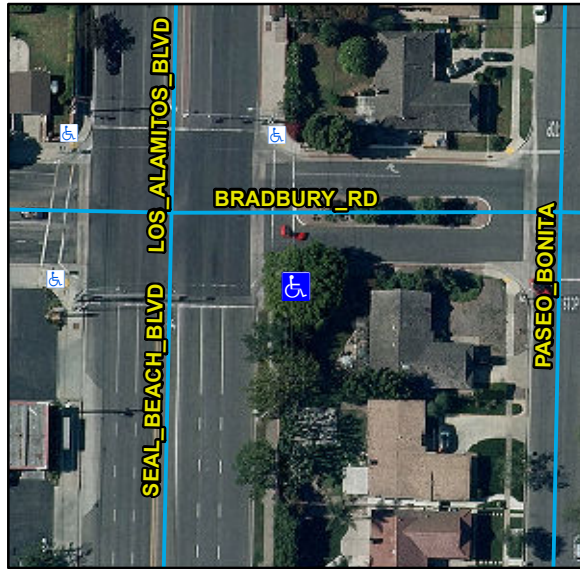
| Compliance | Description | Data | Compliance | Description | Data |
|---|---|---|---|---|---|
| No | Ramp Cross Slope LT (%) | 5 | No | Ramp Cross Slope RT (%) | 5.2 |

Remove & Replace Curb Ramp With Two New Directional Ramps or Equivalent.

R304.5.3, STD 1115
