# Access Compliance Report Public Rights-of-Way (Curb Ramps)

Main Street: BRADBURY\_RD Cross Street: LOS\_ALAMITOS\_BLVD Location: NW

ADA ID: RPRK211221112055 Ramp Type: Type 4 - Parallel Initial Pass/Fail: Fail Overall Compliance: No Severity Score: 2

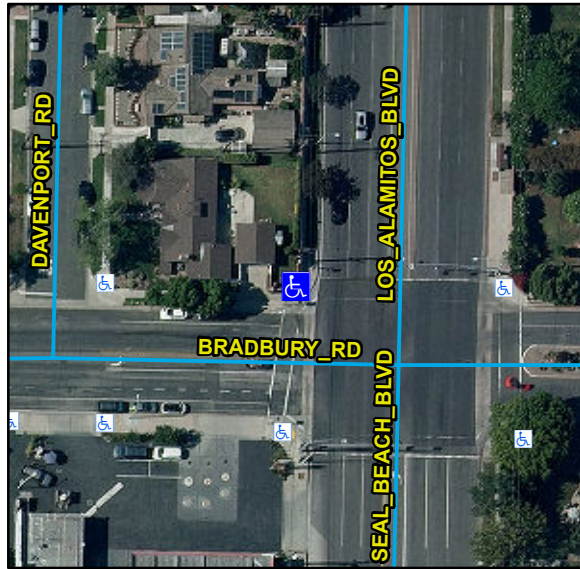
| Compliance | Description | Data | Compliance | Description | Data |
|---|---|---|---|---|---|
| No | Ramp Cross Slope LT (%) | 3.3 | No | Ramp Cross Slope RT (%) | 3.9 |

Remove & Replace Curb Ramp With Two New Directional Ramps or Equivalent.
