# Access Compliance Report

### (Curb Ramps)

Main Street: LOS\_ALAMITOS\_BLV Cross Street: BRADBURY\_RD Location: NE

ADA ID: RPRK211221112625 Ramp Type: Type 4 - Parallel Initial Pass/Fail: Pass Overall Compliance: No Severity Score: 4

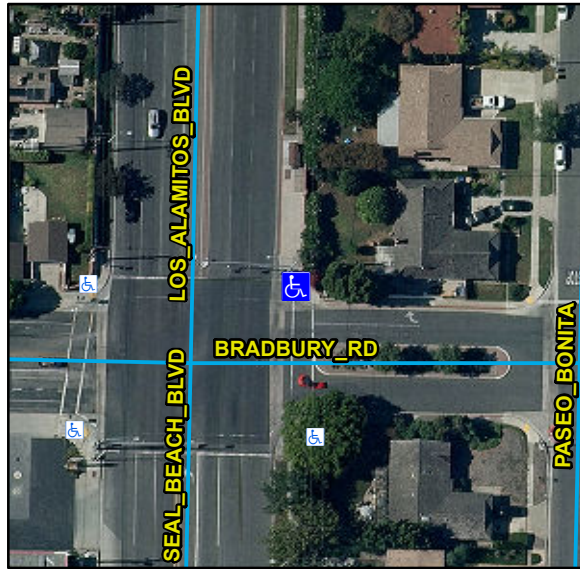
| Compliance | Description | Data | Compliance | Description | Data |
|---|---|---|---|---|---|
| No | Landing Width (in) | 47 | Yes | DWS Length (in) | 36 |

**Remove & Replace Curb Ramp With Two New Directional Ramps or Equivalent.**

**R204.3, R304.2.1, STD 1115**

Total Cost: \$ 4000
