# Access Compliance Report Public Rights-of-Way (Curb Ramps)

Main Street: ORANGEWOOD\_AVE Cross Street: DAVENPORT\_RD Location: SE

ADA ID: RPRK211221113836 Ramp Type: Type 4 - Parallel Initial Pass/Fail: Fail Overall Compliance: No Severity Score: 15

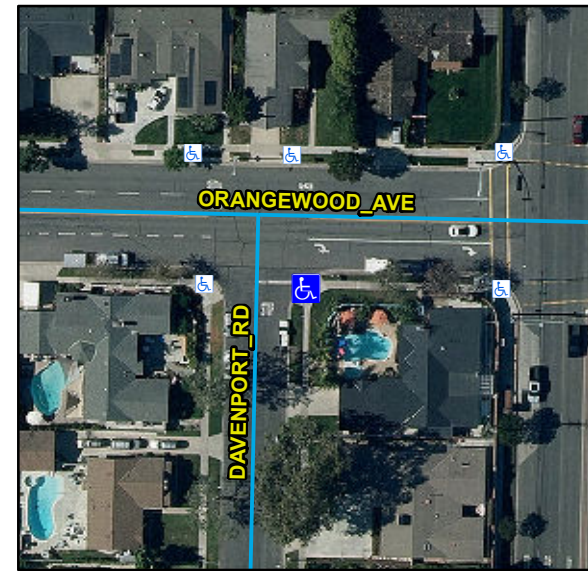
| Compliance | Description | Data | Compliance | Description | Data |
|---|---|---|---|---|---|
| No | Ramp Cross Slope LT (%) | 6.2 | No | Ramp Cross Slope RT (%) | 3.4 |

Remove & Replace Curb Ramp With Two New Directional Ramps or Equivalent.

R204.3, R304.5.3, STD 1115
