# Access Compliance Report Public Rights-of-Way (Curb Ramps)

Main Street: LOS\_ALAMITOS\_BLV Cross Street: ORANGEWOOD\_AVE Location: SW

ADA ID: RPRK211221114131 Ramp Type: Type 4 - Parallel Initial Pass/Fail: Fail Overall Compliance: No Severity Score: 2

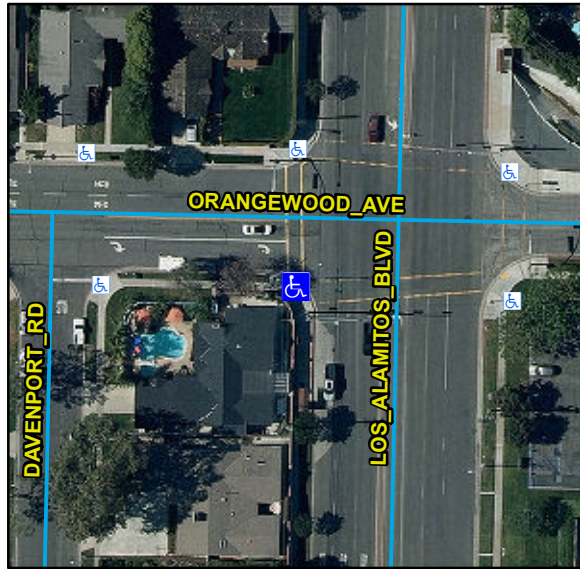
| Compliance | Description | Data | Compliance | Description | Data |
|---|---|---|---|---|---|
| No | Ramp Cross Slope LT (%) | 3.6 | No | Ramp Cross Slope RT (%) | 3.9 |

Remove & Replace Curb Ramp With Two New Directional Ramps or Equivalent.

R304.5.3, STD 1115
