# Access Compliance Report Public Rights-of-Way (Curb Ramps)

Main Street: FOSTER\_RD Cross Street: ST\_ALBANS\_DR Location: NE

ADA ID: RPRK211221115205 Ramp Type: Type 1 - Perpendicular Diagonal Initial Pass/Fail: Pass Overall Compliance: No Severity Score: 10

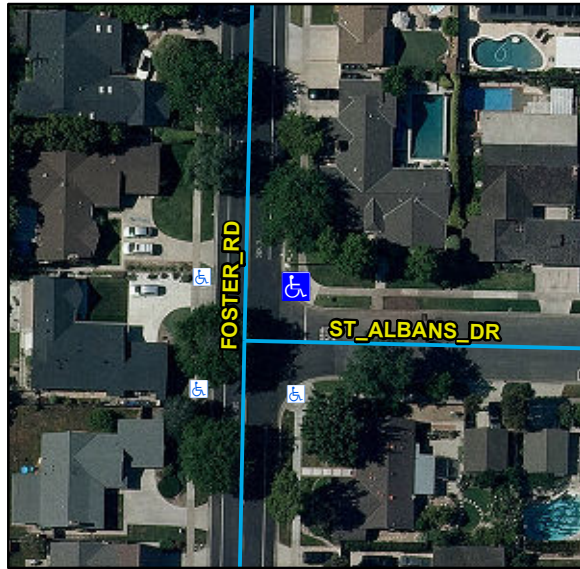
**Remove & Replace Curb Ramp With Two New Directional Ramps or Equivalent. Gutter Ponding Observed.**

| Compliance | Description | Data | Compliance | Description | Data |
|---|---|---|---|---|---|
| No | Landing Run Slope (%) | 3.6 | N/A | Flare Traversable RT | No |
| Yes | Landing Cross Slope (%) | 0.9 | No | DWS Provided | No |
| No | Gutter Ponding | Yes | Yes | Curb Slope | 0.3 |
