# Access Compliance Report Public Rights-of-Way (Curb Ramps)

Main Street: ST\_ALBANS\_DR Cross Street: CHIANTI\_DR Location: SE

ADA ID: RPRK211221120015 Ramp Type: Type 1 - Perpendicular Diagonal Initial Pass/Fail: Pass Overall Compliance: No Severity Score: 10

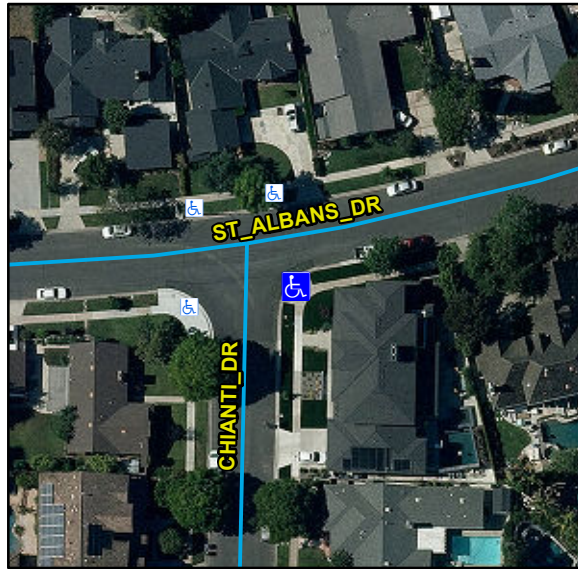
| Compliance | Description | Data | Compliance | Description | Data |
|---|---|---|---|---|---|
| No | Landing Run Slope (%) | 4.2 | N/A | Flare Traversable RT | No |
| Yes | Landing Cross Slope (%) | 1.7 | No | DWS Provided | No |
| No | Gutter Ponding | Yes | Yes | Curb Slope | 1.1 |

Remove & Replace Curb Ramp With Two New Directional Ramps or Equivalent. Gutter Ponding Observed.
