# Access Compliance Report Public Rights-of-Way (Curb Ramps)

Main Street: CHIANTI\_DR Cross Street: ST\_ALBANS\_DR Location: SW

ADA ID: RPRK211221120301 Ramp Type: Type 1 - Perpendicular Diagonal Initial Pass/Fail: Pass Overall Compliance: No Severity Score: 14

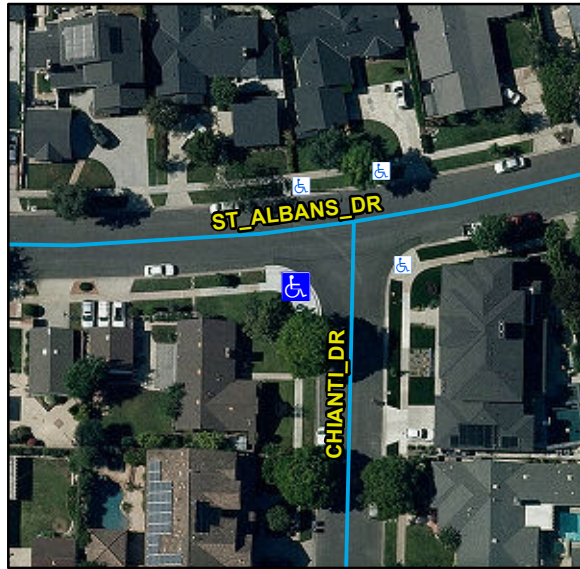
| Compliance | Description | Data | Compliance | Description | Data |
|---|---|---|---|---|---|
| Yes | Landing Cross Slope (%) | 1 | No | DWS Provided | No |

Remove & Replace Curb Ramp With Two New Directional Ramps or Equivalent.

R304.2.1, R305, STD 1115
