# Access Compliance Report Public Rights-of-Way (Curb Ramps)

Main Street: ST\_ALBANS\_DR Cross Street: CHRISTY\_LN Location: SE

ADA ID: RPRK211221120611 Ramp Type: Type 1 - Perpendicular Diagonal Initial Pass/Fail: Pass Overall Compliance: No Severity Score: 12

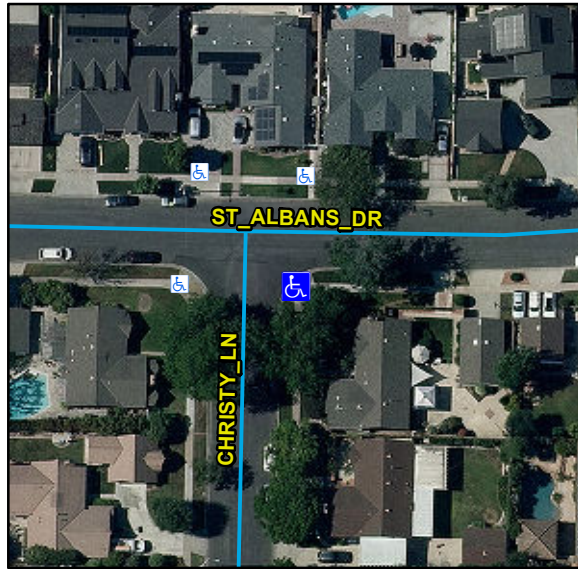
| Compliance | Description | Data | Compliance | Description | Data |
|---|---|---|---|---|---|
| No | Landing Run Slope (%) | 2.9 | N/A | Flare Traversable RT | No |
| Yes | Landing Cross Slope (%) | 0.9 | No | DWS Provided | No |

Remove & Replace Curb Ramp With Two New Directional Ramps or Equivalent.

R204.3, R304.2.2-Perp, R304.3.2-Para, R305, STD 1115

Total Cost: \$ 6160
