# Access Compliance Report Public Rights-of-Way (Curb Ramps)

Main Street: **CHRISTY\_LN** Cross Street: **ST\_ALBANS\_DR** Location: **SW**

ADA ID: **RPRK211221121023** Ramp Type: **Type 1 - Perpendicular Diagonal Initial Pass/Fail: Pass** Overall Compliance: **No** Severity Score: **12**

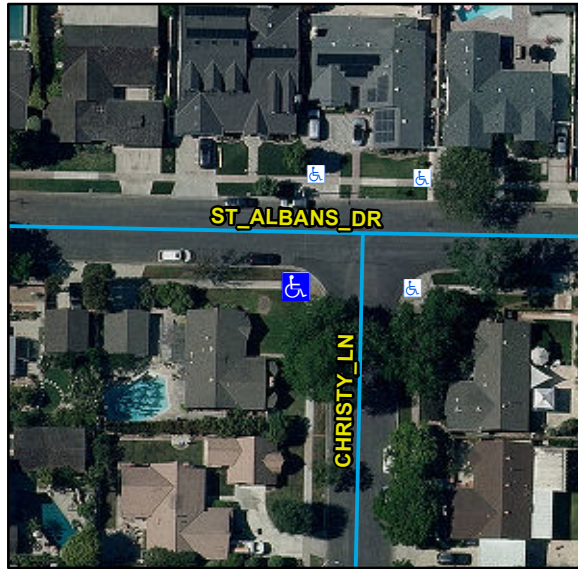
| Compliance | Description | Data | Compliance | Description | Data |
|---|---|---|---|---|---|
| <b>No</b> | Landing Run Slope (%) | <b>2.8</b> | <b>N/A</b> | Flare Traversable RT | <b>No</b> |
| <b>Yes</b> | Landing Cross Slope (%) | <b>0.9</b> | <b>No</b> | DWS Provided | <b>No</b> |

**Remove & Replace Curb Ramp With Two New Directional Ramps or Equivalent.**
