# Access Compliance Report Public Rights-of-Way (Curb Ramps)

Main Street: OAK\_KNOLL\_DR Cross Street: OAK\_LEAF\_DR Location: SE

ADA ID: RPRK211221121909 Ramp Type: Type 1 - Perpendicular Diagonal Initial Pass/Fail: Pass Overall Compliance: No Severity Score: 10

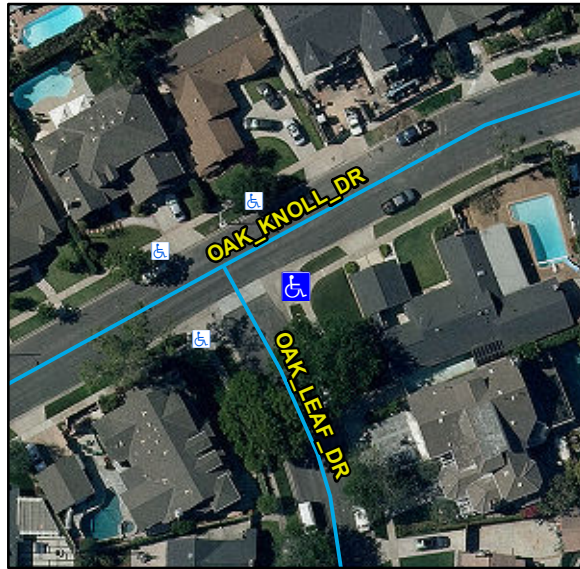
| Compliance | Description | Data | Compliance | Description | Data |
|---|---|---|---|---|---|
| No | Landing Run Slope (%) | 2.7 | N/A | Flare Traversable RT | No |
| Yes | Landing Cross Slope (%) | 0.2 | No | DWS Provided | No |

Remove & Replace Curb Ramp With Two New Directional Ramps or Equivalent.
