# Access Compliance Report Public Rights-of-Way (Curb Ramps)

Main Street: OAK\_KNOLL\_DR Cross Street: OAK\_KNOLL\_DR Location: SW

ADA ID: RPRK211221122157 Ramp Type: Type 1 - Perpendicular Diagonal Initial Pass/Fail: Fail Overall Compliance: No Severity Score: 16

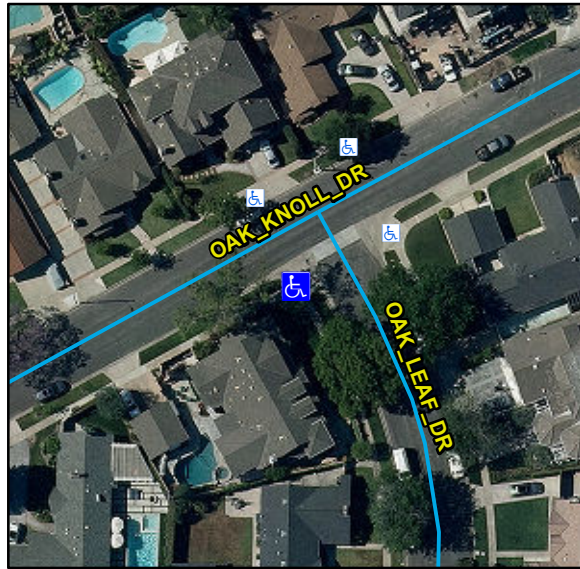
| Compliance | Description | Data | Compliance | Description | Data |
|---|---|---|---|---|---|
| No | Ramp Run Slope (%) | 8.4 | N/A | Flare Slope LT (%) | N/A |

Remove & Replace Curb Ramp With Two New Directional Ramps or Equivalent.

R204.3, R304.2.2, STD 1115
