# Access Compliance Report Public Rights-of-Way (Curb Ramps)

Main Street: KEMPTON\_DR Cross Street: FOSTER\_RD Location: SE

ADA ID: RPRK211221124159 Ramp Type: Type 1 - Perpendicular Diagonal Initial Pass/Fail: Pass Overall Compliance: No Severity Score: 4

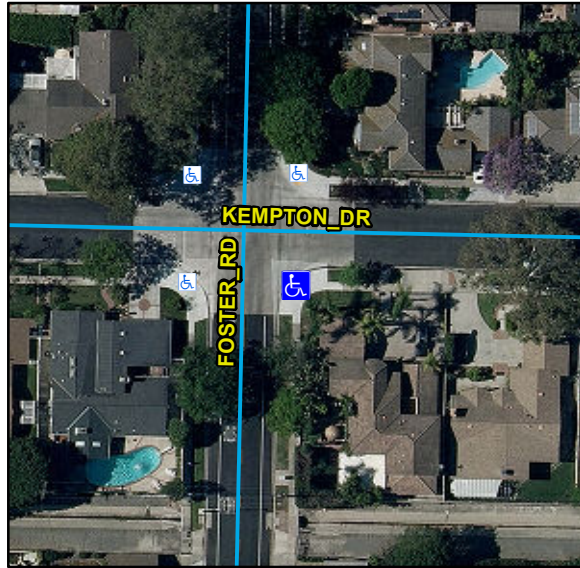
| Compliance | Description | Data | Compliance | Description | Data |
|---|---|---|---|---|---|
| Yes | Gutter Ponding | No | No | Curb Slope | 6.9 |

**Remove & Replace Curb Ramp With Two New Directional Ramps or Equivalent.**

**R304.2.2, R304.2.1, STD 1115**
