# Access Compliance Report Public Rights-of-Way (Curb Ramps)

Main Street: FOSTER\_RD Cross Street: KEMPTON\_DR Location: SW

ADA ID: RPRK211221124550 Ramp Type: Type 1 - Perpendicular Diagonal Initial Pass/Fail: Fail Overall Compliance: No Severity Score: 15

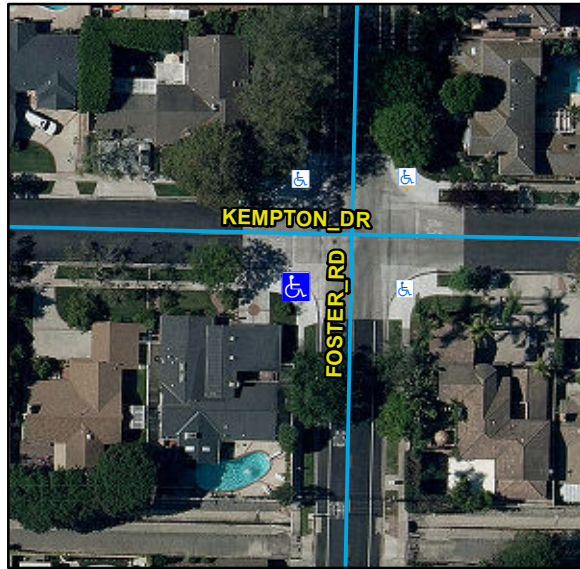
| Compliance | Description | Data | Compliance | Description | Data |
|---|---|---|---|---|---|
| No | Ramp Run Slope (%) | 8.4 | N/A | Flare Slope LT (%) | N/A |

Remove & Replace Curb Ramp With Two New Directional Ramps or Equivalent.

R304.2.2, STD 1115
