# Access Compliance Report Public Rights-of-Way (Curb Ramps)

Main Street: KEMPTON\_DR Cross Street: CHRISTY\_LN Location: NW

ADA ID: RPRK211221125315 Ramp Type: Type 1 - Perpendicular Diagonal Initial Pass/Fail: Pass Overall Compliance: No Severity Score: 14

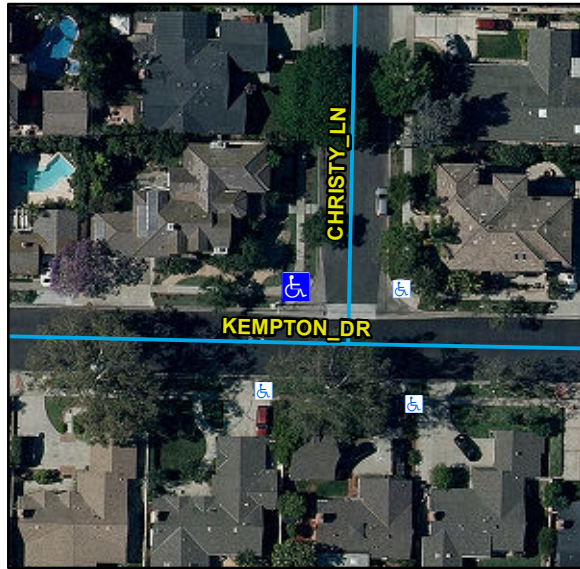
| Compliance | Description | Data | Compliance | Description | Data |
|---|---|---|---|---|---|
| No | Landing Run Slope (%) | 2.5 | N/A | Flare Traversable RT | No |
| Yes | Landing Cross Slope (%) | 1.5 | No | DWS Provided | No |

**Remove & Replace Curb Ramp With Two New Directional Ramps or Equivalent.**

**R204.3, R304.2.1, R304.2.2-Perp, R304.3.2-Para, R305, STD 1115**
