# Access Compliance Report Public Rights-of-Way (Curb Ramps)

Main Street: CHRISTY\_LN Cross Street: KEMPTON\_DR Location: NE

ADA ID: RPRK211221125634 Ramp Type: Type 1 - Perpendicular Diagonal Initial Pass/Fail: Pass Overall Compliance: No Severity Score: 12

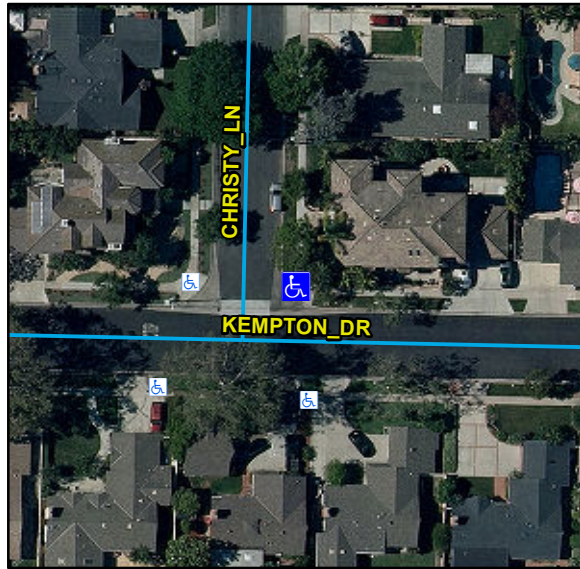
| Compliance | Description | Data | Compliance | Description | Data |
|---|---|---|---|---|---|
| No | Landing Run Slope (%) | 2.1 | N/A | Flare Traversable RT | No |
| Yes | Landing Cross Slope (%) | 0.3 | No | DWS Provided | No |
| No | Gutter Ponding | Yes | Yes | Curb Slope | 3.1 |
| No | Gutter Lip Height (in) | 0.25 | | Road Run Slope (%) | 0.6 |

**Remove & Replace Curb Ramp With Two New Directional Ramps or Equivalent. Grind Gutter Lip.**

**R204.3, R304.2.2-Perp, R304.3.2-Para, R305, R302.7, R302.7.2, STD 1115**
