# Access Compliance Report Public Rights-of-Way (Curb Ramps)

Main Street: KEMPTON\_DR Cross Street: CHIANTI\_DR Location: NW

ADA ID: RPRK211221125925 Ramp Type: Type 1 - Perpendicular Diagonal Initial Pass/Fail: Fail Overall Compliance: No Severity Score: 16

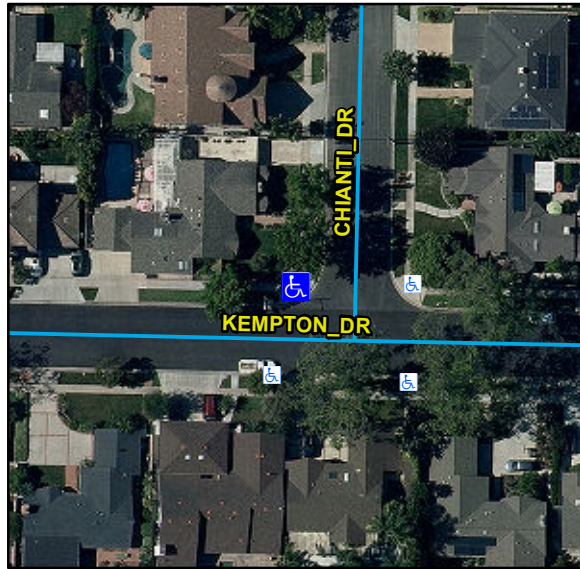
| Compliance | Description | Data | Compliance | Description | Data |
|---|---|---|---|---|---|
| No | Ramp Run Slope (%) | 8.4 | N/A | Flare Slope LT (%) | N/A |

Remove & Replace Curb Ramp With Two New Directional Ramps or Equivalent.

R304.2.2, R204.3, STD 1115
