# Access Compliance Report Public Rights-of-Way (Curb Ramps)

Main Street: CHIANTI\_DR Cross Street: KEMPTON\_DR Location: NE

ADA ID: RPRK211221130206 Ramp Type: Type 1 - Perpendicular Diagonal Initial Pass/Fail: Fail Overall Compliance: No Severity Score: 16

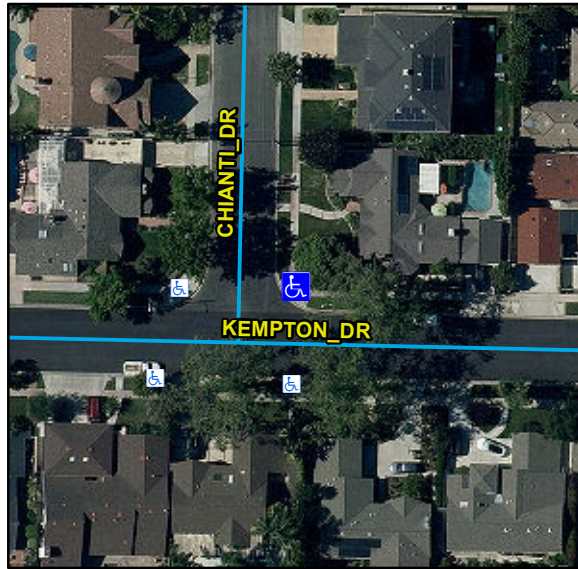
| Compliance | Description | Data | Compliance | Description | Data |
|---|---|---|---|---|---|
| No | Ramp Run Slope (%) | 9 | N/A | Flare Slope LT (%) | N/A |

Remove & Replace Curb Ramp With Two New Directional Ramps or Equivalent.

R304.2.2, R204.3, STD 1115
