# Access Compliance Report Public Rights-of-Way (Curb Ramps)

Main Street: KEMPTON\_DR Cross Street: BALLANTINE\_DR Location: NW

ADA ID: RPRK211221130516 Ramp Type: Type 1 - Perpendicular Diagonal Initial Pass/Fail: Fail Overall Compliance: No Severity Score: 15

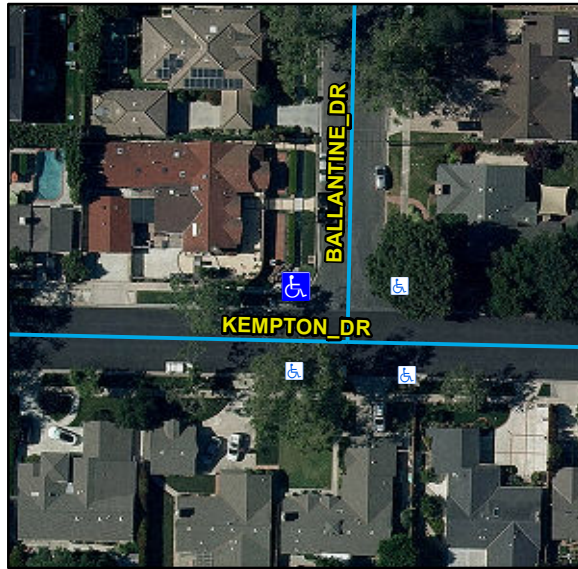
R304.2.2, R204.3, STD 1115

| Compliance | Description | Data | Compliance | Description | Data |
|---|---|---|---|---|---|
| No | Ramp Run Slope (%) | 8.7 | N/A | Flare Slope LT (%) | N/A |

Remove & Replace Curb Ramp With Two New Directional Ramps or Equivalent.
