# Access Compliance Report Public Rights-of-Way (Curb Ramps)

Main Street: BALLANTINE\_DR Cross Street: KEMPTON\_DR Location: NE

ADA ID: RPRK211221130747 Ramp Type: Type 1 - Perpendicular Diagonal Initial Pass/Fail: Fail Overall Compliance: No Severity Score: 16

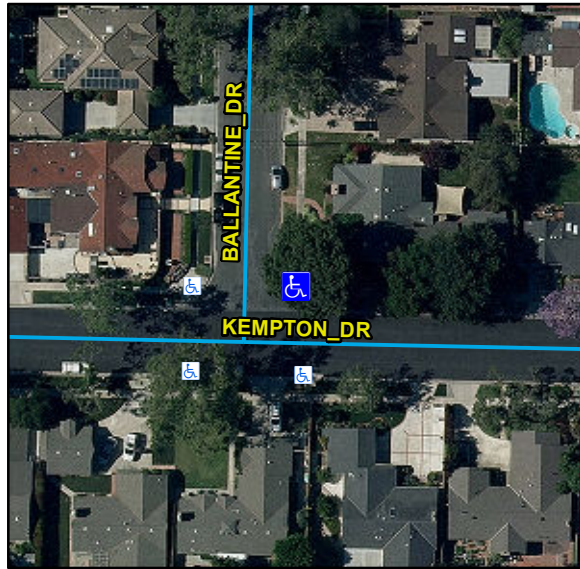
| Compliance | Description | Data | Compliance | Description | Data |
|---|---|---|---|---|---|
| No | Ramp Run Slope (%) | 9.1 | N/A | Flare Slope LT (%) | N/A |

Remove & Replace Curb Ramp With Two New Directional Ramps or Equivalent.

R304.2.2, R204.3, STD 1115
