# Access Compliance Report Public Rights-of-Way (Curb Ramps)

Main Street: KEMPTON\_DR Cross Street: OAK\_LEAF\_DR Location: NW

ADA ID: RPRK211221130942 Ramp Type: Type 1 - Perpendicular Diagonal Initial Pass/Fail: Fail Overall Compliance: No Severity Score: 15

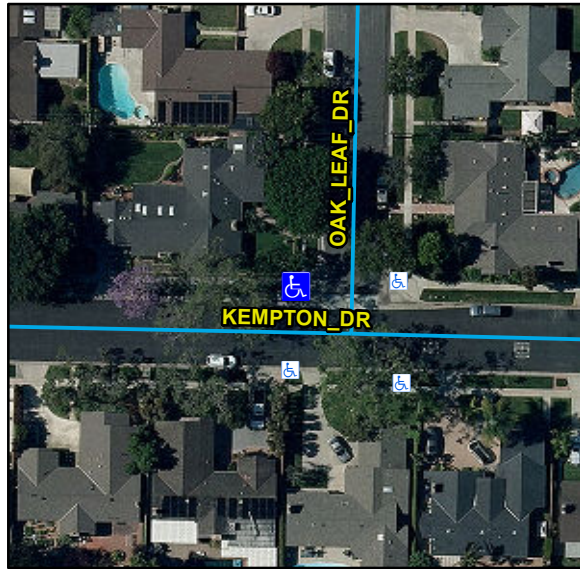
| Compliance | Description | Data | Compliance | Description | Data |
|---|---|---|---|---|---|
| No | Ramp Run Slope (%) | 8.5 | N/A | Flare Slope LT (%) | N/A |

Remove & Replace Curb Ramp With Two New Directional Ramps or Equivalent.

R204.3, R304.2.2, STD 1115
