# Access Compliance Report Public Rights-of-Way (Curb Ramps)

Main Street: OAK\_LEAF\_DR Cross Street: KEMPTON\_DR Location: NE

ADA ID: RPRK211221131213 Ramp Type: Type 1 - Perpendicular Diagonal Initial Pass/Fail: Pass Overall Compliance: No Severity Score: 12

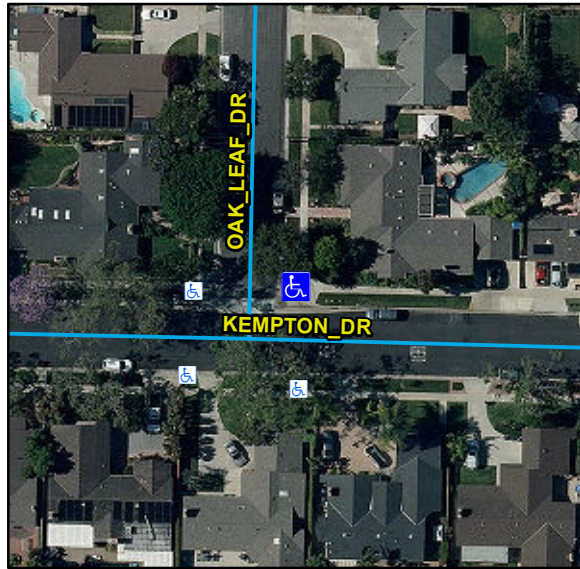
| Compliance | Description | Data | Compliance | Description | Data |
|---|---|---|---|---|---|
| No | Landing Run Slope (%) | 3.2 | N/A | Flare Traversable RT | No |
| Yes | Landing Cross Slope (%) | 1.2 | No | DWS Provided | No |
| Yes | Overall Surface Condition: Acceptable | | No | Perp Joint Present | No |

**Remove & Replace Curb Ramp With Two New Directional Ramps or Equivalent.**
