# Access Compliance Report Public Rights-of-Way (Curb Ramps)

Main Street: SALMON\_DR Cross Street: KENSINGTON\_RD Location: E

ADA ID: RPRK211221131952 Ramp Type: Type 1 - Perpendicular Initial Pass/Fail: Pass Overall Compliance: No Severity Score: 9

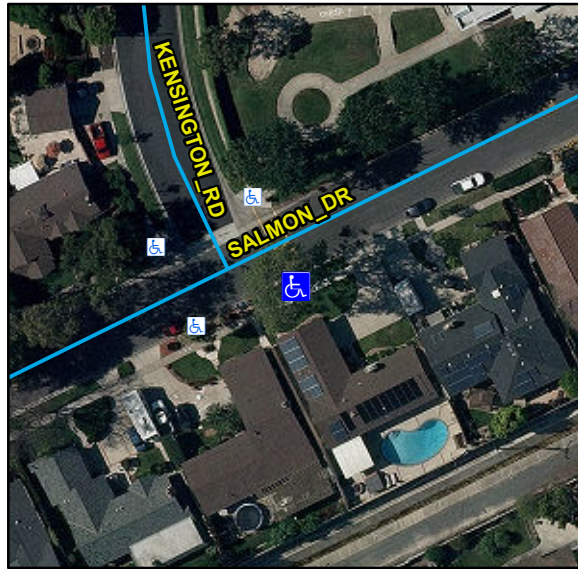
| Compliance | Description | Data | Compliance | Description | Data |
|---|---|---|---|---|---|
| No | Gutter Ponding | Yes | Yes | Curb Slope | 3.9 |
| No | Gutter Run Slope (%) | 7.7 | | Road Cross Slope (%) | N/A |

Remove & Replace Landing. Remove & Replace Gutter.
