# Access Compliance Report Public Rights-of-Way (Curb Ramps)

Main Street: N\_MUSTANG\_AVE Cross Street: RANDALL\_ST Location: NE

ADA ID: RPRK211222113303 Ramp Type: Type 4 - Parallel Initial Pass/Fail: Fail Overall Compliance: No Severity Score: 16

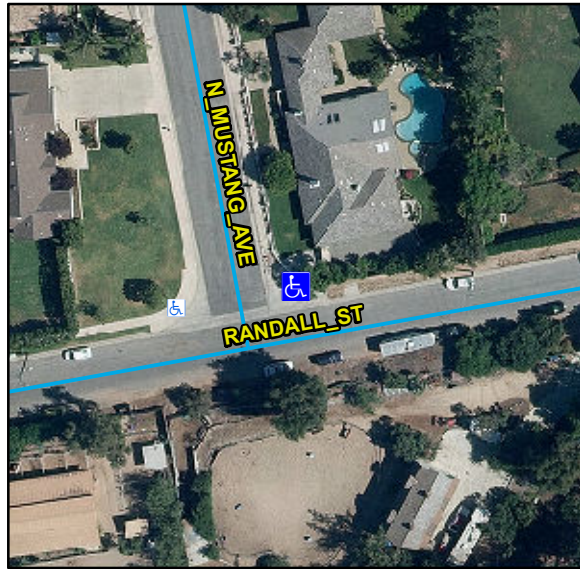
| Compliance | Description | Data | Compliance | Description | Data |
|---|---|---|---|---|---|
| Yes | Ramp Run Slope LT (%) | 0.8 | No | Ramp Run Slope RT (%) | 9.4 |
| No | Ramp Cross Slope LT (%) | 5 | No | Ramp Cross Slope RT (%) | 3.3 |

**Remove & Replace Curb Ramp With Two New Directional Ramps or Equivalent.**

**R304.5.3, R304.3.2, STD 1115**
