# Access Compliance Report Public Rights-of-Way (Curb Ramps)

Main Street: RANDALL\_ST Cross Street: N\_MUSTANG\_AVE Location: NW

ADA ID: RPRK211222113642 Ramp Type: Type 4 - Parallel Initial Pass/Fail: Fail Overall Compliance: No Severity Score: 30

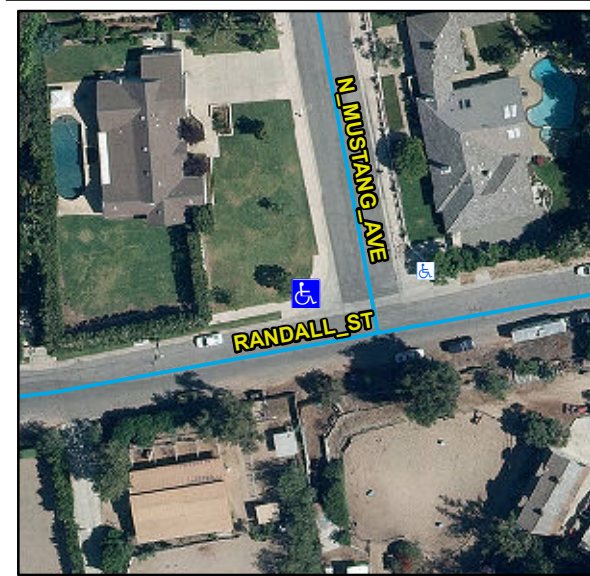
| Compliance | Description | Data | Compliance | Description | Data |
|---|---|---|---|---|---|
| No | Ramp Run Slope LT (%) | 10.6 | Yes | Ramp Run Slope RT (%) | 0.6 |
| Yes | Ramp Cross Slope LT (%) | 2 | No | Ramp Cross Slope RT (%) | 6.1 |

Possible Solutions:  
**Remove & Replace Curb Ramp With Two New Directional Ramps or Equivalent.**

OC Std/PROW:  
**R304.3.2, R304.5.3, STD 1115**
