# Access Compliance Report Public Rights-of-Way (Curb Ramps)

Main Street: N\_STALLION\_ST Cross Street: RANDALL\_ST Location: NE

ADA ID: RPRK211222114020 Ramp Type: Type 4 - Parallel Initial Pass/Fail: Fail Overall Compliance: No Severity Score: 16

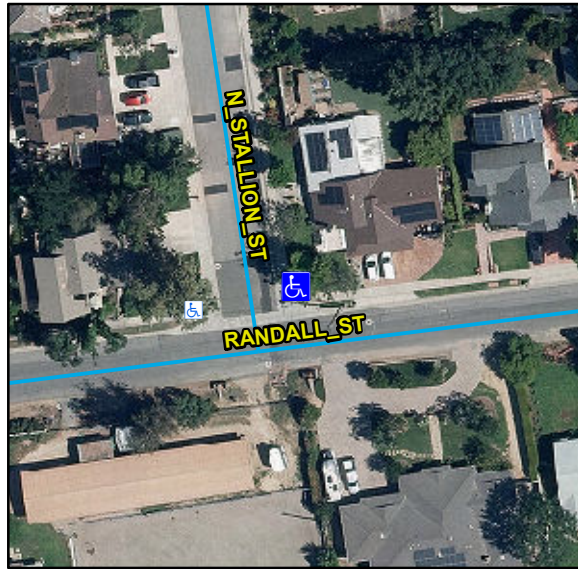
| Compliance | Description | Data | Compliance | Description | Data |
|---|---|---|---|---|---|
| Yes | Ramp Run Slope LT (%) | 5.9 | No | Ramp Run Slope RT (%) | 9.8 |
| No | Ramp Cross Slope LT (%) | 2.9 | No | Ramp Cross Slope RT (%) | 2.9 |

Remove & Replace Curb Ramp With Two New Directional Ramps or Equivalent.

R304.5.3, R304.3.2, STD 1115
