# Access Compliance Report Public Rights-of-Way (Curb Ramps)

Main Street: RANDALL\_ST Cross Street: N\_STALLION\_ST Location: NW

ADA ID: RPRK211222114315 Ramp Type: Type 4 - Parallel Initial Pass/Fail: Fail Overall Compliance: No Severity Score: 16

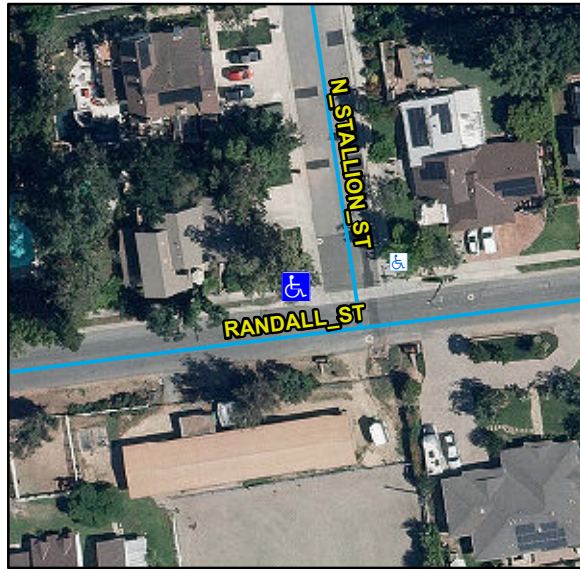
R304.5.3, R304.3.2, STD 1115

| Compliance | Description | Data | Compliance | Description | Data |
|---|---|---|---|---|---|
| Yes | Ramp Run Slope LT (%) | 4.4 | No | Ramp Run Slope RT (%) | 8.9 |
| No | Ramp Cross Slope LT (%) | 2.3 | Yes | Ramp Cross Slope RT (%) | 1.5 |

Remove & Replace Curb Ramp With Two New Directional Ramps or Equivalent.
