# Access Compliance Report Public Rights-of-Way (Curb Ramps)

Main Street: N\_STALLION\_ST Cross Street: E\_ARABIAN\_AVE Location: NE

ADA ID: RPRK211222115039 Ramp Type: Type 4 - Parallel Initial Pass/Fail: Fail Overall Compliance: No Severity Score: 15

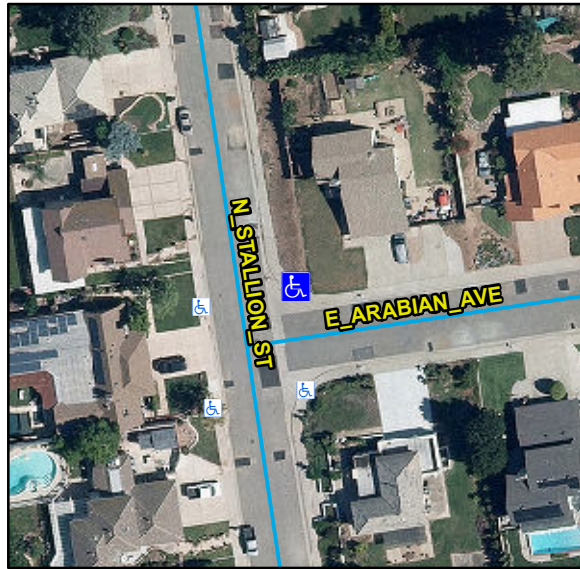
| Compliance | Description | Data | Compliance | Description | Data |
|---|---|---|---|---|---|
| No | Obstructions Present? | Yes | N/A | Utilities Present? | No |
| | Obstruction Types | Street Sign | | Utility Types | |

| Compliance | Description | Data | Compliance | Description | Data |
|---|---|---|---|---|---|
| Yes | Ramp Run Slope LT (%) | 4 | No | Ramp Run Slope RT (%) | 9.5 |

Remove & Replace Curb Ramp With Two New Directional Ramps or Equivalent.

R304.3.2, R302.3, R402.2, STD 1115
