# Access Compliance Report Public Rights-of-Way (Curb Ramps)

Main Street: ORANGE\_PARK\_BLVD Cross Street: ORANGE\_PARK\_BLVD Location: W

ADA ID: RPRK211222120319 Ramp Type: Type 4 - Parallel Initial Pass/Fail: Fail Overall Compliance: No Severity Score: 2

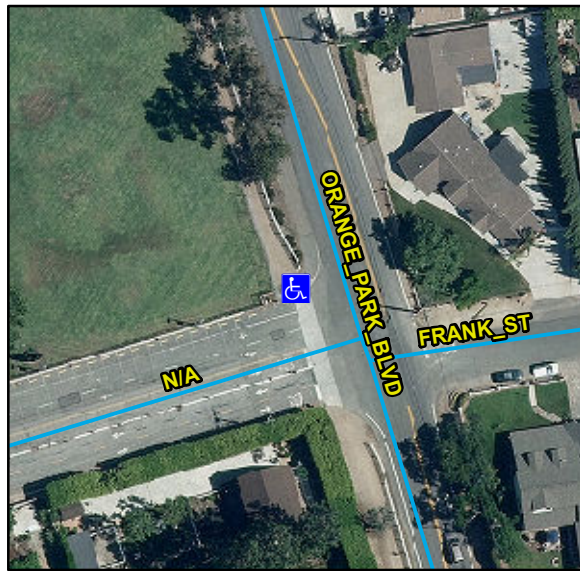
| Compliance | Description | Data | Compliance | Description | Data |
|---|---|---|---|---|---|
| No | Ramp Cross Slope LT (%) | 2.7 | Yes | Ramp Cross Slope RT (%) | 0.1 |

Remove & Replace Curb Ramp With Two New Directional Ramps or Equivalent.

R304.5.3, STD 1115
