# Access Compliance Report Public Rights-of-Way (Curb Ramps)

Main Street: N\_LINDA\_VISTA\_ST Cross Street: VILLA\_PARK\_RD Location: SW

ADA ID: RPRK211222121407 Ramp Type: Type 1 - Perpendicular Diagonal Initial Pass/Fail: Fail Overall Compliance: No Severity Score: 16

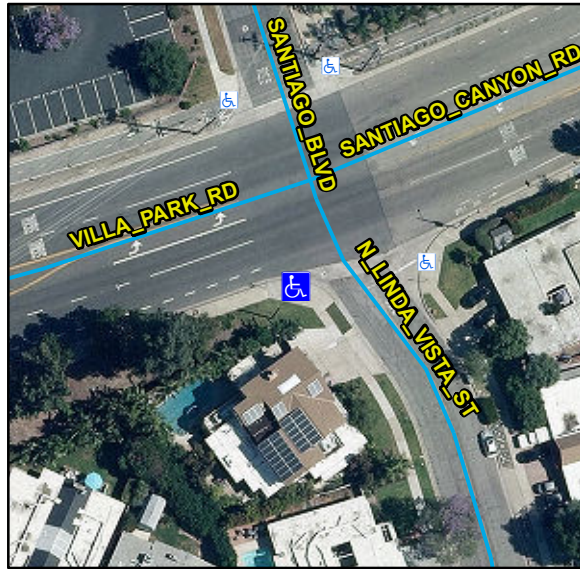
| Compliance | Description | Data | Compliance | Description | Data |
|---|---|---|---|---|---|
| No | Ramp Run Slope (%) | 11.3 | N/A | Flare Slope LT (%) | N/A |
| No | Ramp Cross Slope (%) | 2.2 | N/A | Flare Traversable LT | N/A |
| No | Gutter Lip Height (in) | 0.25 | | Road Run Slope (%) | 1.9 |

Remove & Replace Curb Ramp With Two New Directional Ramps or Equivalent. Grind Gutter Lip.

R304.2.2, R304.5.3, R302.7.2, STD 1115
