# Access Compliance Report Public Rights-of-Way (Curb Ramps)

Main Street: SANTIAGO\_BLVD Cross Street: SANTIAGO\_CANYON\_RD Location: NE

ADA ID: RPRK211222121835 Ramp Type: Blended Transition 2 Initial Pass/Fail: Fail Overall Compliance: No Severity Score: 15

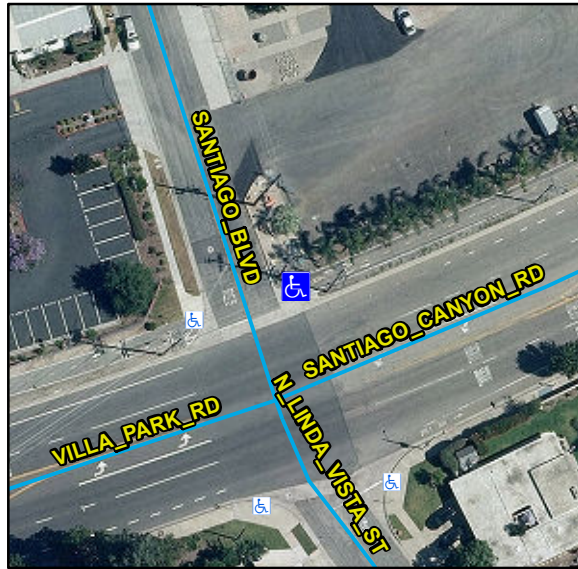
| Compliance | Description | Data | Compliance | Description | Data |
|---|---|---|---|---|---|
| No | Ramp Run Slope (%) | 9 | N/A | Flare Slope RT (%) | N/A |

Remove & Replace Curb Ramp With Two New Directional Ramps or Equivalent.

R304.2.2, STD 1115
