# Access Compliance Report Public Rights-of-Way (Curb Ramps)

Main Street: N\_MEADS\_AVE Cross Street: N\_MEADS\_AVE Location: NW

ADA ID: RPRK211222125135 Ramp Type: Type 1 - Perpendicular Diagonal Initial Pass/Fail: Pass Overall Compliance: No Severity Score: 20

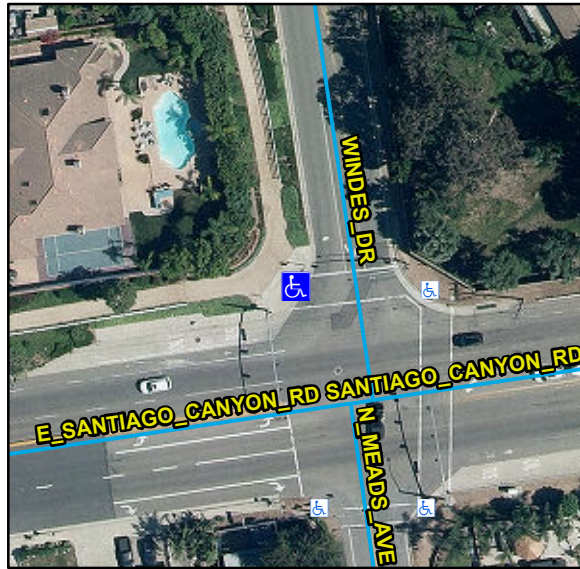
| Compliance | Description | Data | Compliance | Description | Data |
|---|---|---|---|---|---|
| Yes | Landing Cross Slope (%) | 0.6 | No | DWS Provided | No |
| No | Gutter Lip Height (in) | 0.5 | | Road Run Slope (%) | 0.6 |
| No | Gutter Run Slope (%) | 10.2 | | Road Cross Slope (%) | 3.2 |

Install Detectable Warning System. Remove & Replace Gutter.
