# Access Compliance Report Public Rights-of-Way (Curb Ramps)

Main Street: RANDALL\_ST Cross Street: RANDALL\_ST Location: SE

ADA ID: RPRK211222130524 Ramp Type: Type 4 - Parallel Initial Pass/Fail: Fail Overall Compliance: No Severity Score: 2

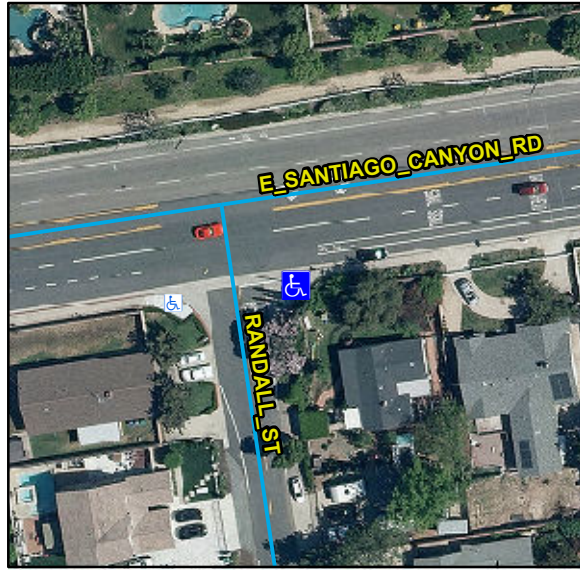
| Compliance | Description | Data | Compliance | Description | Data |
|---|---|---|---|---|---|
| No | Ramp Cross Slope LT (%) | 2.4 | Yes | Ramp Cross Slope RT (%) | 2 |

Remove & Replace Curb Ramp With Two New Directional Ramps or Equivalent.

R304.5.3, STD 1115

Total Cost: \$ 4000
